**NORTH SOUTH HIGHWAY PROJECT -
JAMAICA**

**ENVIRONMENTAL MONITORING
REPORT # 8 – SECTON 3**

**NORTH SOUTH HIGHWAY PROJECT –
JAMAICA (Moneague to Ocho Rios)**

**ENVIRONMENTAL MONITORING REPORT
8 (June 2014)**

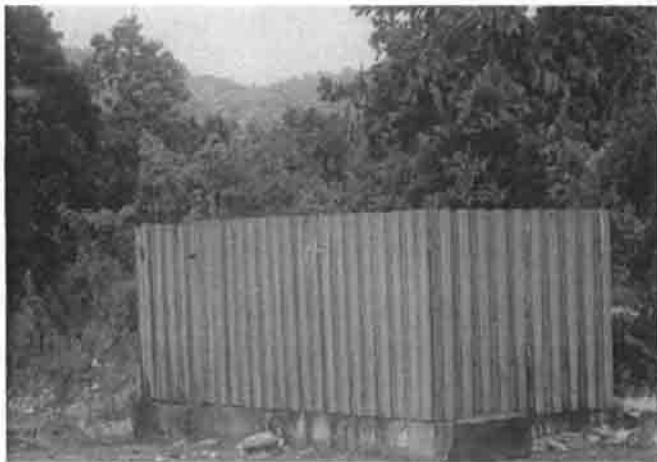
- Few major construction sites were without suitable solid waste container.
- Area around refused bay at campsite was in need of sanitization (*see figure 1*).
- Refuse bay (campsite) was breeding a lot of flies due to unbagged garbage.

Figure 1: Showing refuse bay at Golden Grove Campsite where garbage was kept in on unhealthy conditions.

- Clean up area around refuse bay and sanitized with bleach solution
- Place garbage into plastic bag prior to be stored into refuse bay
- Increase garbage collection for disposal

- Up to end of monitoring period, none of the above suggestions made to the construction team was acted up on.
- Further follow up will be done.

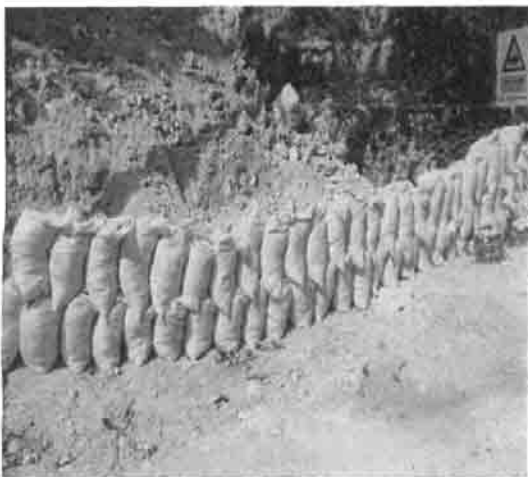
- Shoot drains were being built along embankments to direct storm water run-off from high way.
- Sand bags were placed at K 65 + 305 and K 61 + 500 to reduce the sediments load of storm water run-off at these locations (see figure 2).
- No work was being done adjacent to any river, stream, or rivulet

Figure 2: Showing sand bags placed at K 61 + 500 to prevent erosion of marly earth material into adjacent drain and onto the public thoroughfare.

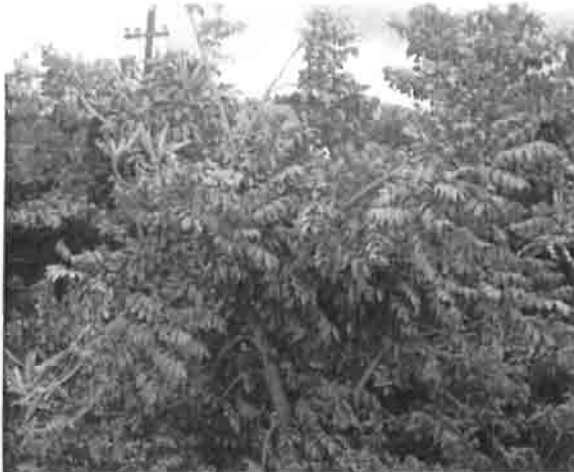
- Dust complaints from residents of Johnson Town, Lydford, Steer Town etc.
- Dust complaints from workers
- Access roads frequently got dusty.
- Wetting was inadequate in a number of areas, including Johnson Town, Lydford, Golden Grove round-a-bout, Steer Town etc.
- Leaves of trees defaced with dust particles – Johnson Town, Lydford etc. – see figure 3.

Figure 3: Dust particles from construction sites covering leaves of trees in the Johnson Town area due to inadequate wetting.

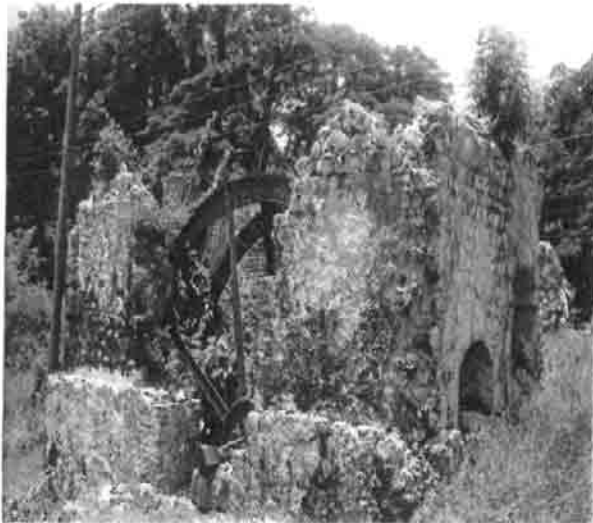
Figure 4: Showing old water wheel of old sugar work (Mammee Bay), a heritage site, which might be affected by the road construction.

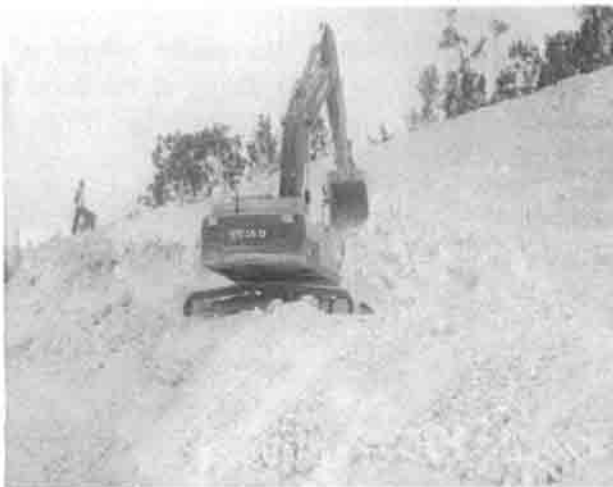
- Shoot drains continued to be constructed down filled embankments in the Golden Grove and Belmont area in order to prevent erosion of the road embankments by storm water run-off.
- Benching of embankments, as an erosion protection measure, was observed where cutting was necessary to bring elevation to design level (see figure 5).

Figure 5: Showing excavator cutting bench near Phoenix Park, St. Ann.

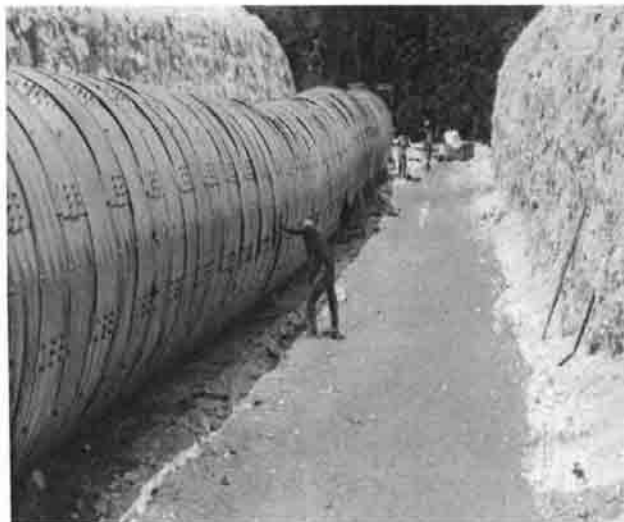
- CPS drain pipe continued to be construction at specific location in accordance to the approved drainage plan (see figure 6).

Figure 6: CPS drain pipe being installed at a low point along the alignment.

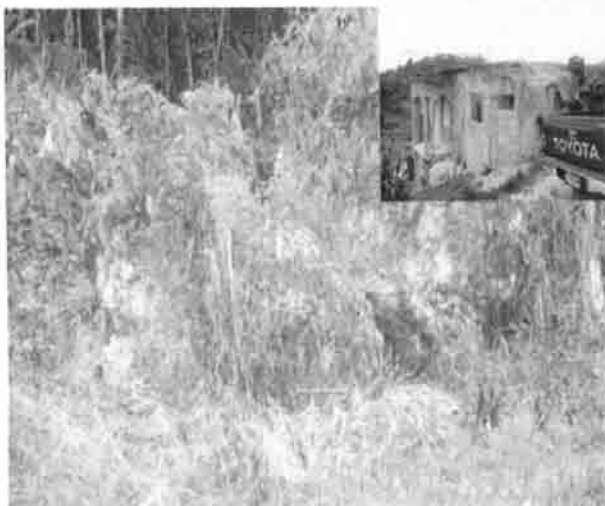
- Large boulders that were precariously perched, threatening the house of Mr. Graham, at K 47 + 800 were removed prior to blasting (see figure 8).

Figure 8: Showing boulders precariously perched above house (inset) at K 47 + 800 during the pre- blasting survey.

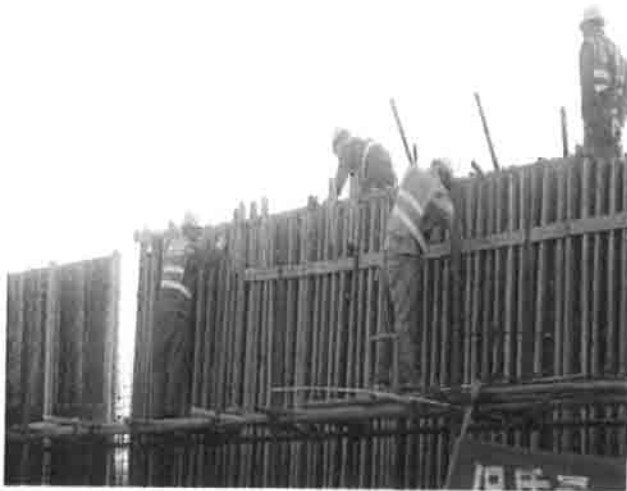
- On June 19th, 2014, a number of workers began to work over very deep holes, being constructed for bridge footings, without wearing any harness – Lydford Interchange.
- Workers working at height without harness (see figure 9).
- Few workers without hard boots
- Some affected workers were without dust mask.
- Stagnant water in container breed mosquitoes and producing a foul odour (see figure 10).
- Unlicensed fuel truck belonging to construction team using public road (see figure 11).

Figure 9: *Workers at height without wearing any harness at box culvert construction site at about K 56 +.*

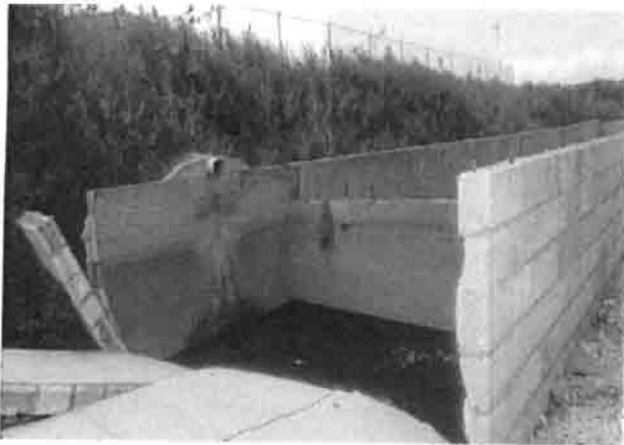
Figure 10: *Stagnant water, a breeding site for mosquitoes.*

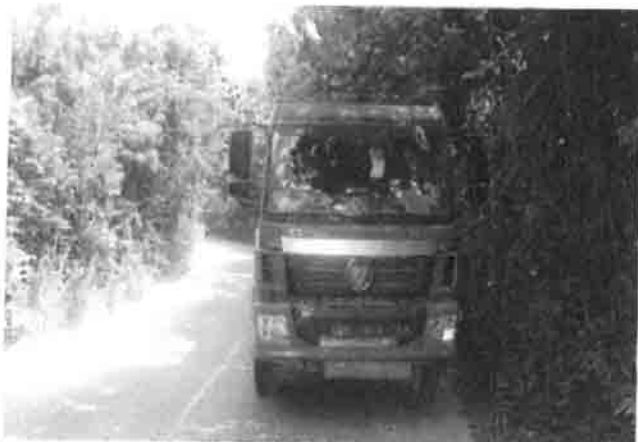
Figure 11: *Unlicensed fuel truck seen on the Chalky Hill truck road.*
