**NATIONAL ENVIRONMENT AND PLANNING AGENCY
Enforcement Branch Post Planning/Permit/License Monitoring**

Permitted Activity: Construction and Operation of Hotel or Resort Complex of 501 to 1000 rooms

Location of Activity: Ruthland Pen, Norman Manley Boulevard, Negril, Hanover

Permittee: BBNH Resorts Limited

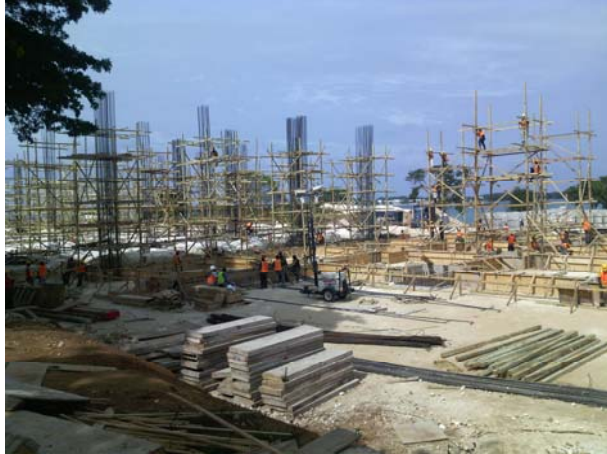
- The outline and orientation of the main building varied considerably from what was approved. The building’s layout and outline did not reflect what was approved by the Agency.

Photo 1: Work underway on the erection of the main building. Photo taken 29 January 2016 by NEPA Officer.

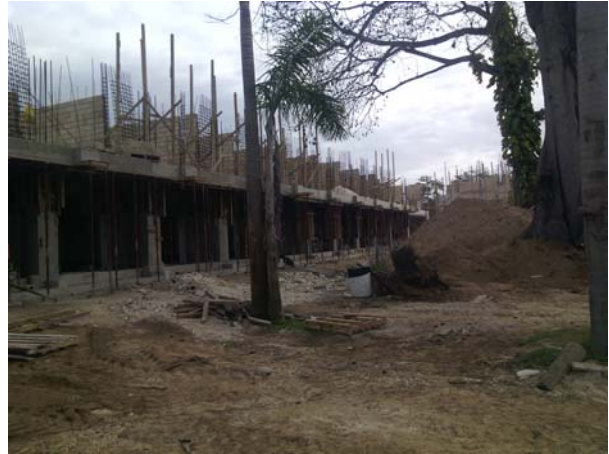
- Buildings 1, 2 and 3 were not being erected as approved as there were changes in the outline and layout. The visit conducted revealed that the ground floor of buildings 1 & 2 had 2 extra rooms than what was approved (14 instead of 12). Should the number of floors be retained, an extra 8 rooms will result from the two blocks.

Photo 2: A view of the stage of construction of building 1, under construction contrary to the approved drawings. Photo taken 29 January 2016 by NEPA Officer.

- Cessation Order to be served, as the developer is undertaken a development contrary to what is permitted.
- Notice of Suspension for the breaches noted in the compliance table

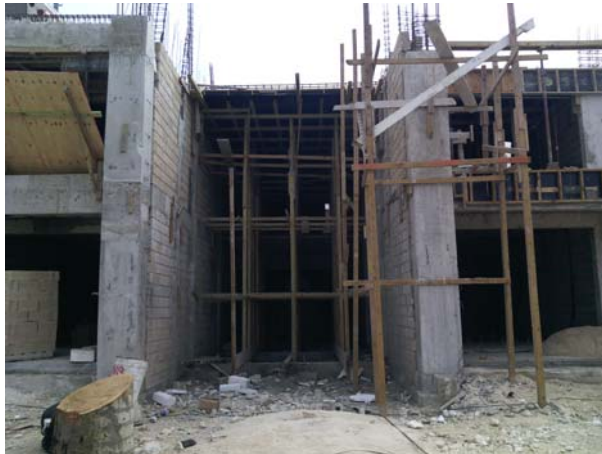
- The break between buildings 2 and 3 was none existent as a structure was being constructed in that area. This was contrary to the approved design (photo 3).
- A similar situation was observed between buildings 12 and 13.

Photo 3: The structure occupying the proposed break between buildings 1 and 2. Work underway on the erection of the main building. Photo taken 29 January 2016 by NEPA Officer.

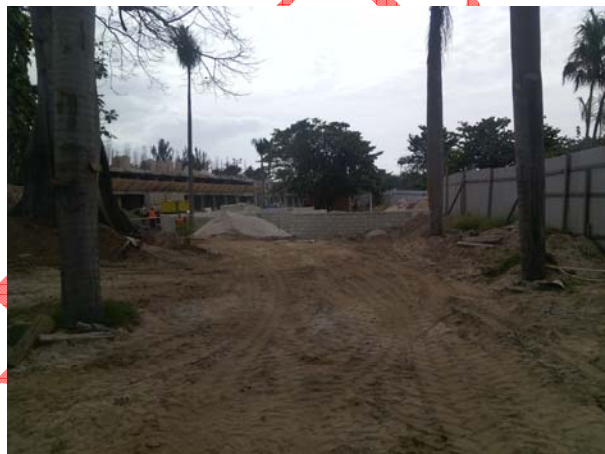
Photo 4: Work underway on the erection of the main building. Photo taken 29 January 2016 by NEPA Officer.

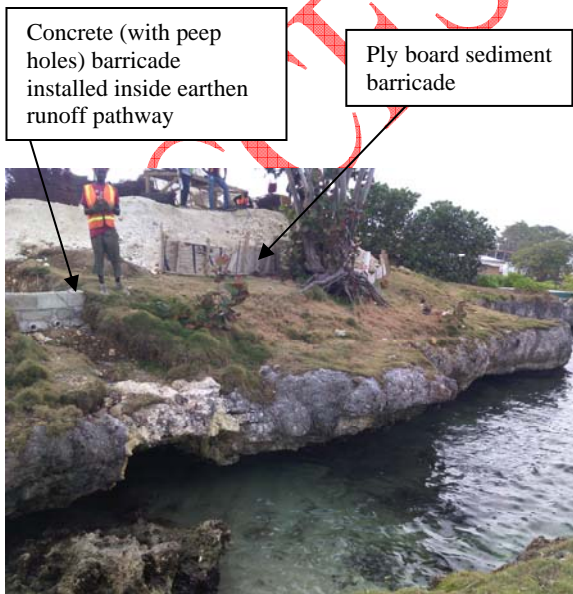
and the mechanism employed appeared insufficient (photos 5-7).
34	The Permittee shall ensure that construction materials including soil and marl are stored away from surface drainage channels and features.	NC	Stockpiles of soil remained at a drainage feature adjacent to the marine environment (photo 5). A mechanism was employed to contain marl being washed from the immediate stockpiles into a natural drainage pathway, however, stockpiles of material edging the water column continued, without any berms in place (photo 7).
35	The Permittee shall ensure that the noise level during construction does not exceed 70 dB at the boundary of the site.	NA	The condition could not be assessed as the requisite equipment for measurement of noise level was not available for use at the time of the inspection.
36	The Permittee shall ensure that work is carried out between the hours of 7:00 a.m. and 6:00 p.m. from Mondays to Fridays and 8:00 a.m. and 6:00 p.m. on Saturdays. There shall be no work on Sundays and Public Holidays. Any work to be done outside of this period will require the permission of the Authority.	NA	At the time of the visit, the condition could not be assessed due to the time of the inspection. At a previous visit, however, during routing Post Permit Monitoring, construction work was observed beyond 6: 00 pm. A Site Warning Notice (# 8828) was served. Previously, the Agency investigated complaints of work taking place beyond stipulated hours. This was confirmed. However, the work was limited to the pouring of concrete in the casting of the foundation of some of the buildings. Since then, the Agency has not received any further complaint.

Photo 5: The sediment baffle that was put in place for some stockpiles along the marine environment. Photo taken 29 January 2016 by NEPA Officer.

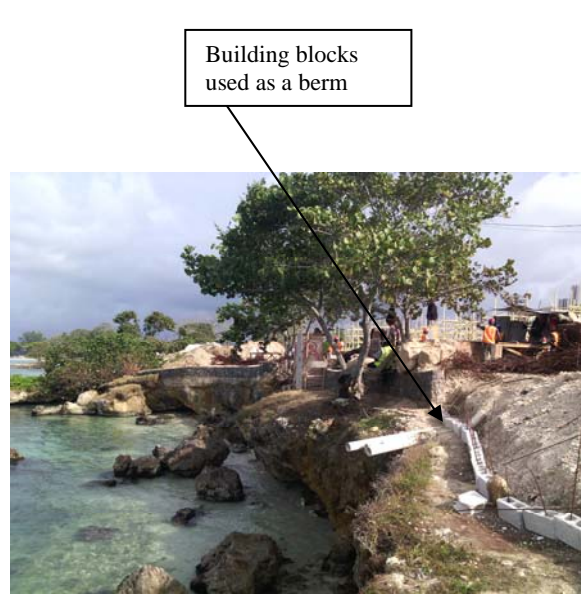
- The developer had made some attempts with respect to the containment of soil and construction materials on the lands. However, the mechanisms were inadequate (as shown below in photos 6-7) and stockpiles remained to be setback from the marine environment (photo 8).

Photo 6: The sediment baffle that was put in place for some stockpiles along the marine environment. Photo taken 29 January 2016 by NEPA Officer.

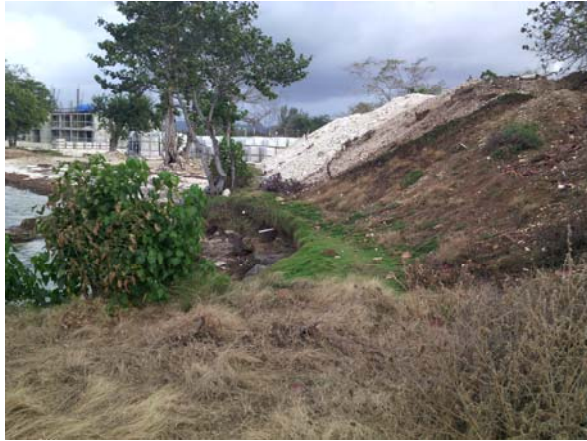
47.	The Permittee shall ensure that all material stockpiles are contained within berms covered with an impervious material and stored away from drainage channels.	NC	As per condition numbers 33 & 34, the storage of soil and construction materials were being inadequately addressed. Uncovered marl and other construction material were observed at the fringes of the water column, without being covered or bermed. This was not being complied with, despite a warning notice (#8822) previously issued.

Photo 7: Stockpiles of soil and marl at the water's edge, without any berm or covering. Photo taken 29 January 2016 by NEPA Officer

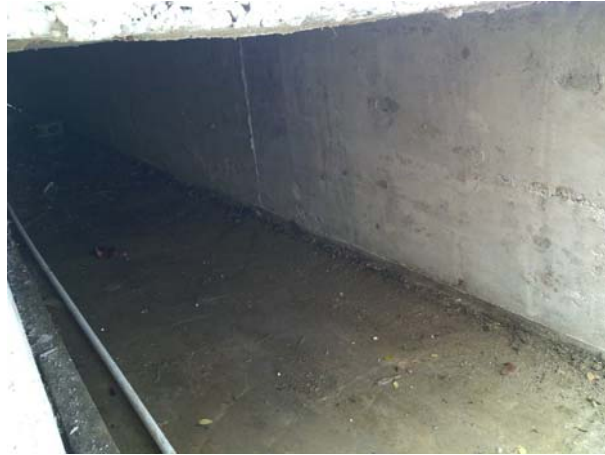
Photo 8: Inside the box culvert leading to the marine environment. Note there were no sediment traps inside the drain. Photo taken 29 January 2016 by NEPA Officer

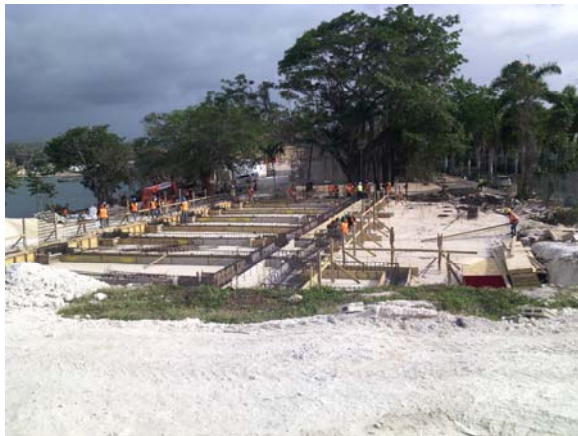
- The outline and layout of buildings 7 and 8, as built, deferred from what was approved.
- Buildings 11-13 were not built as illustrated on approved plan i.e. position and outline layout has changed.

Photo 9: Building 13 at foundation stage. Photo taken 29 January 2016 by NEPA Officer

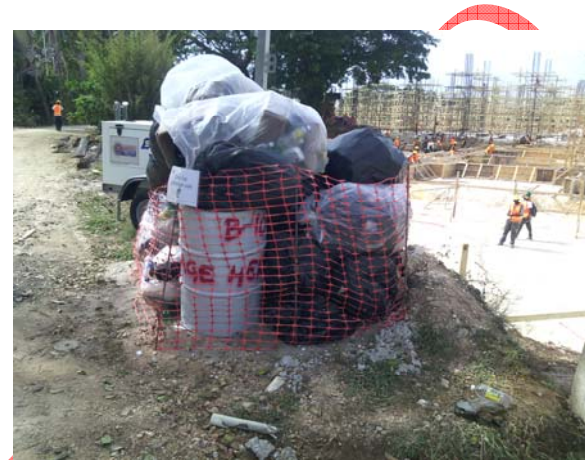
the approval shall be submitted to the Agency prior to the commencement of the development.		<p>However, marl excavated from the site was being transported to a dumpsite which was not an approved NSWMA municipal site and which was not authorized by the Agency.</p> <p>A Site Warning Notice (#8828) was issued prior on 19 January 2016. Earlier, the Site Manager was advised to commence the authorization process at an inspection stemming from investigation of a report, on 16 January 2016. No communication was had from the Permittee in this regard, however.</p>
26	The Permittee shall ensure that there is no burning of waste and/or debris on site.	Full	No burning was observed on site at the time of the inspection.
27	The Permittee shall provide proper waste receptacles for solid waste collection onsite.	Full	Waste receptacles were installed at different locations across the property and garbage collection sites were marked (photo 10).

Photo 10: Solid waste stored and bounded off on the site. Several of these were across the property. Photo taken 29 January 2016 by NEPA Officer
